Proceedings of the Fábos Conference on Landscape and Greenway Planning

Landscape, Ecological and Visual Impacts of a Stream Restoration in Hungary

In the course of the preparation for the restoration of the Váli-stream, an environmental impact assessment (EIA) and, as a part of it, foundational wildlife and landscape protection studies were carried out. The goal of the study is to reveal the significant impacts of a planned stream restoration on wildlife protection, and later on, to propose mitigation measures on the adverse effects. The other main goal of the study is to evaluate the intervention's effects on the landscape, regarding the landscape character, land use, landscape structure and scenery as well.

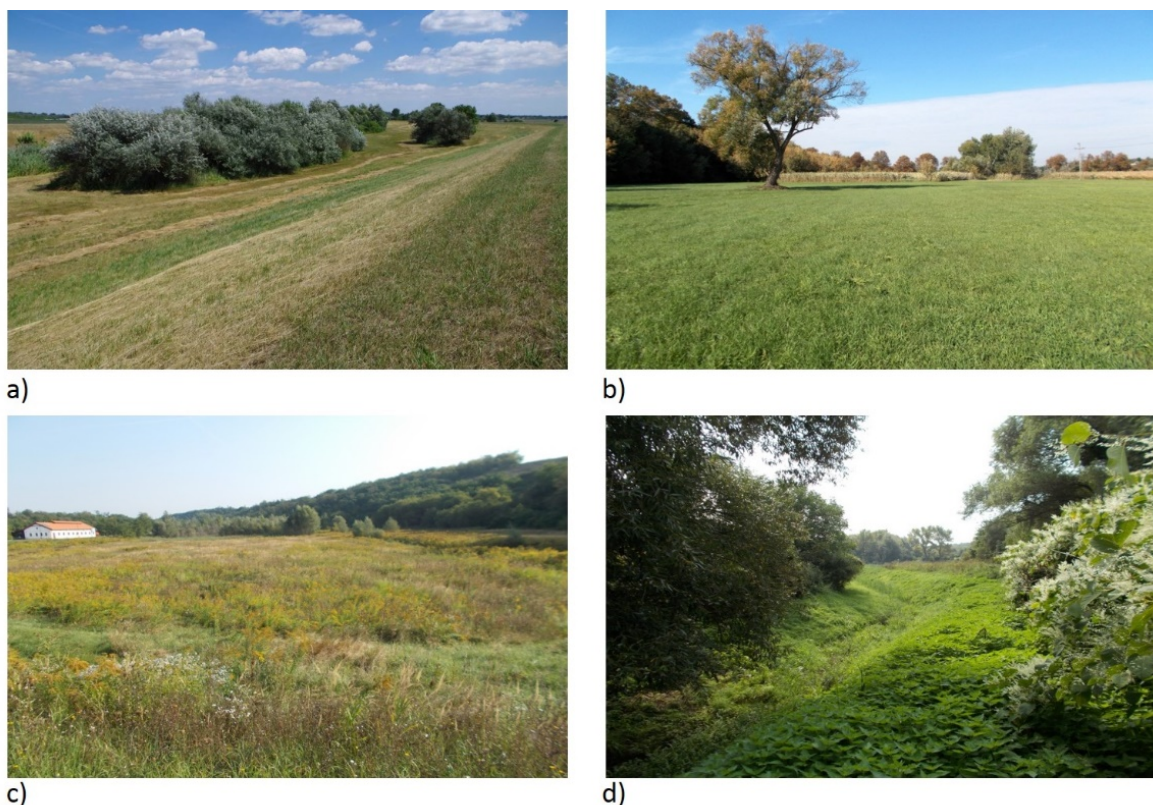
Figure 3. Actual vegetation in the impact area: a) uncharacteristic mesic grasslands and invasive Russian olive stands; b) wet hay meadows and reed beds; c) stands of invasive forbs and pioneer softwood forests; d) fragments of willow-poplar woodlands and ruderal tall-herb vegetation
